**MarkWest Houston Gas Plant  
Inspection Report  
Chartiers, Pennsylvania**

Region III Office of Air Enforcement & Compliance Assistance  
Inspection Date: April 28-30, 2015

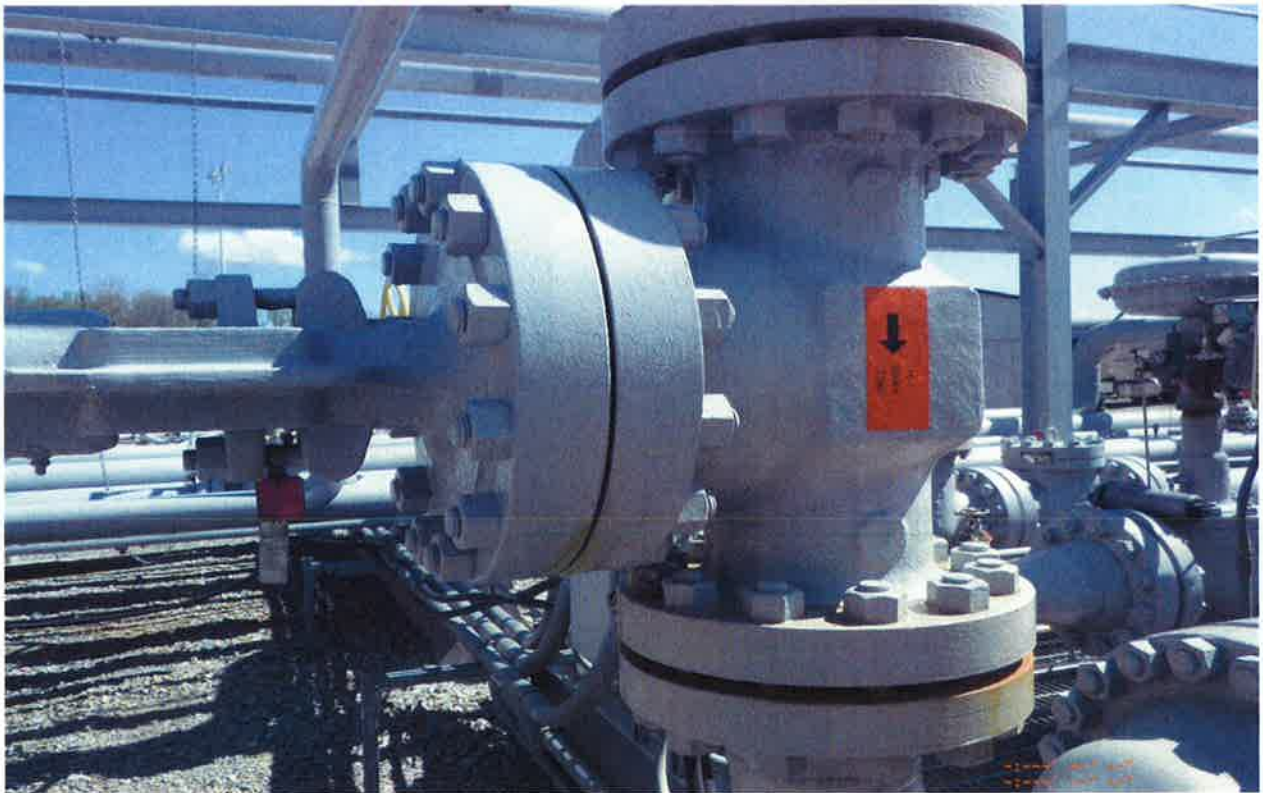
1. Houston 1 Residue Gas Line w/LDAR Tag 000240 – MarkWest Houston – 04/28/2015

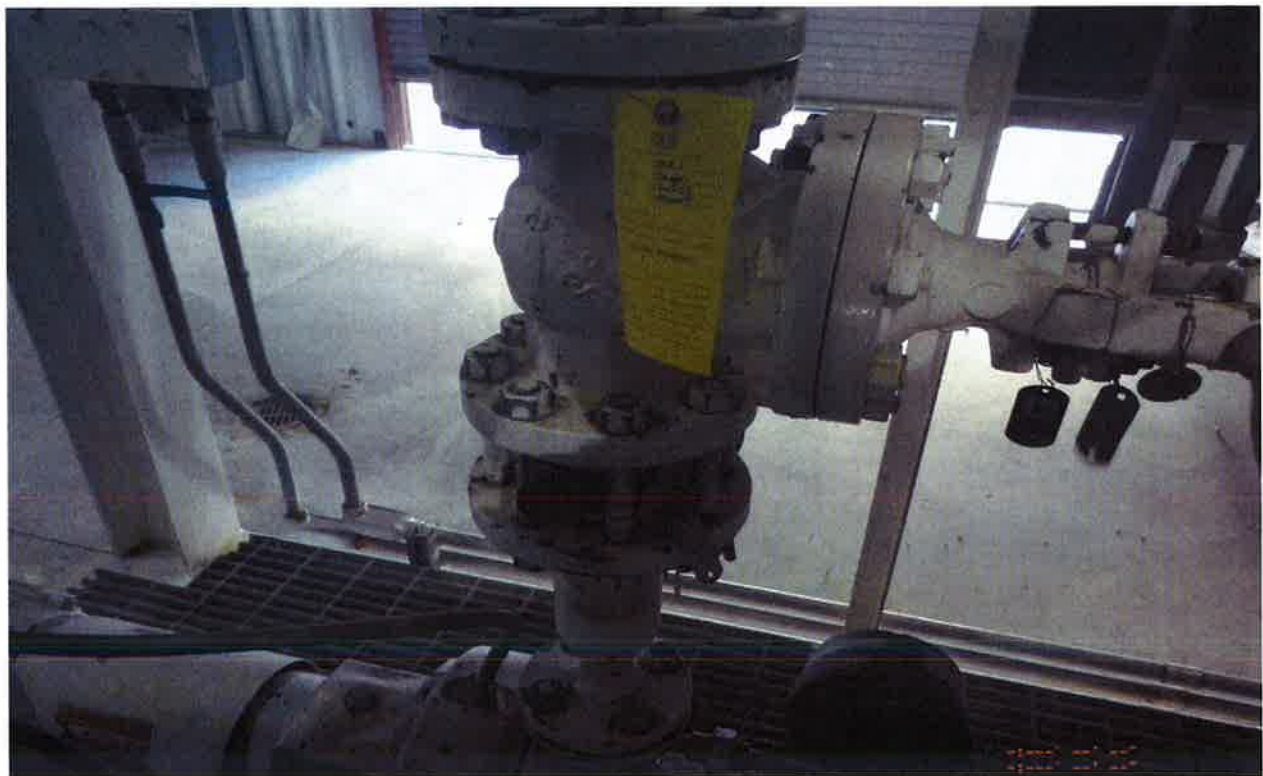
- There were six new stainless steel valves observed on the H1 inlet line near component 000195 that were not identified as part of the LDAR program.
- An LDAR leak tag was observed on component 1703.1 that was leaking on 12/12/13. No recheck date was listed on the LDAR tag (See Photo 2 on Page 1 of Inspection Photos).
- Multiple LDAR tags (24) were observed on the residue line in this area.<sup>5</sup>

2. ISS Leak Tag on Flange 001703 – MarkWest Houston – 04/28/2015

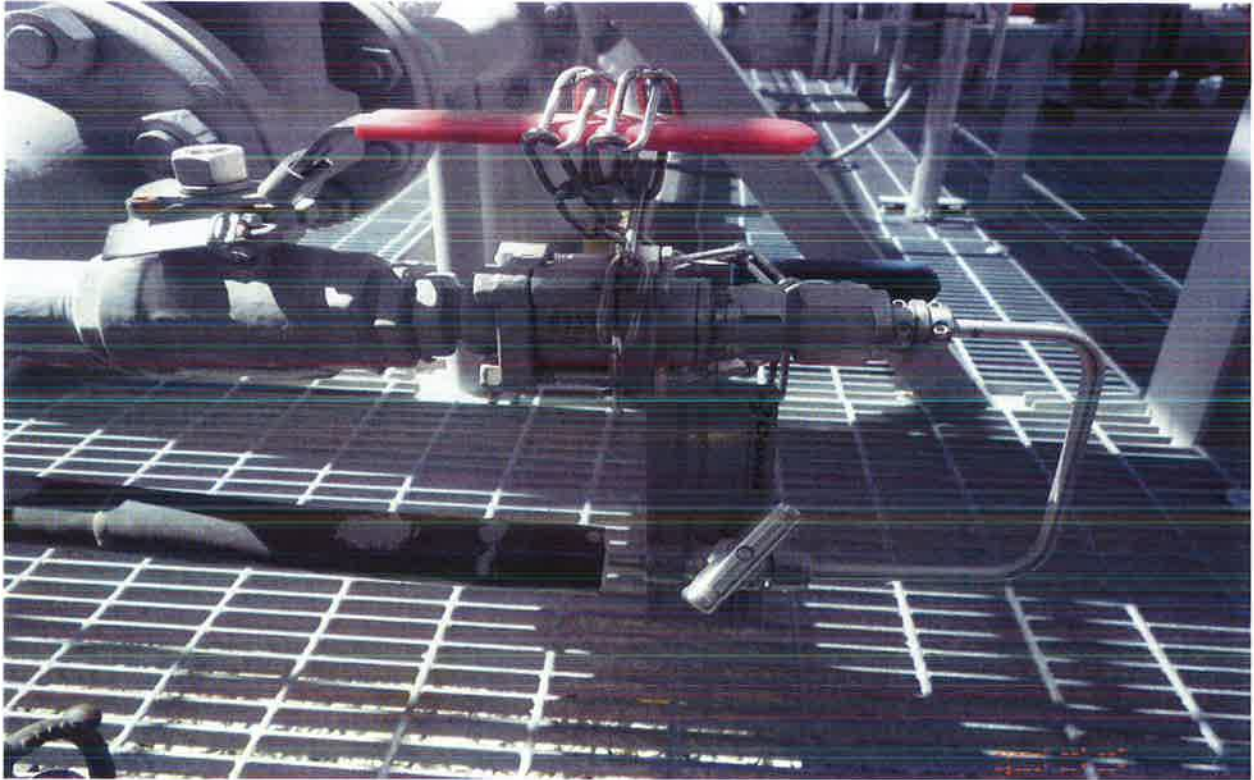
- Two valves to the left of 004368 have no tags and three valves above tag 004353 are not tagged. Six additional unmarked valves were observed in Frac 1.
- One open ended line at 004348 was observed and was leaking with a concentration of 600ppm. This leak was confirmed by ISS with a reading of 1428ppm
- All bleeder valves that are part of the instrumentation assemblies (also called vent plugs) are not tagged as part of the LDAR program for the facility (See Photo 4 on Page 2 of the Inspection Photos).

6. Untagged valves at De-propanizer 4 – MarkWest Houston – 04/28/2015

7. Closer view of untagged valves at De-propanizer 4 skid – MarkWest Houston – 04/28/2015

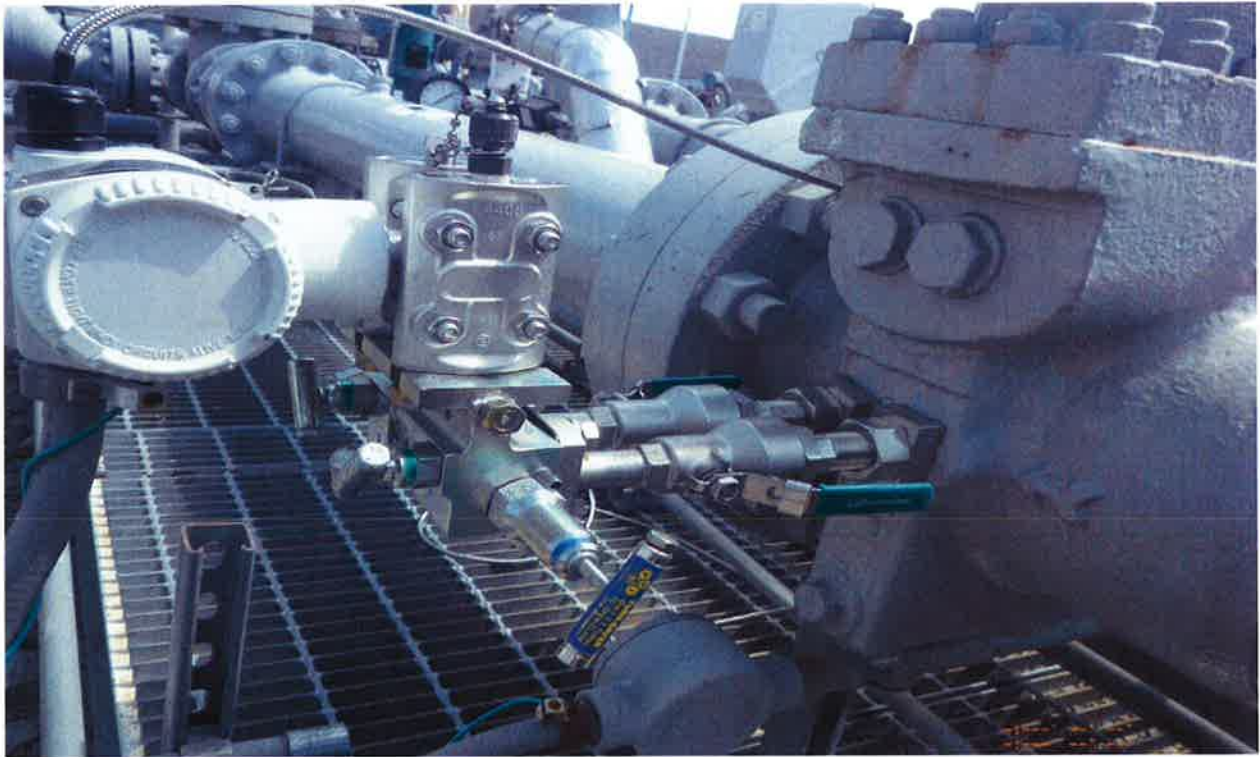
8. Seven untagged valves near 000194 in Houston 1 Inlet – MarkWest Houston – 04/28/2015

9. Seven untagged valves in Houston 1 Inlet – MarkWest Houston – 04/28/2015

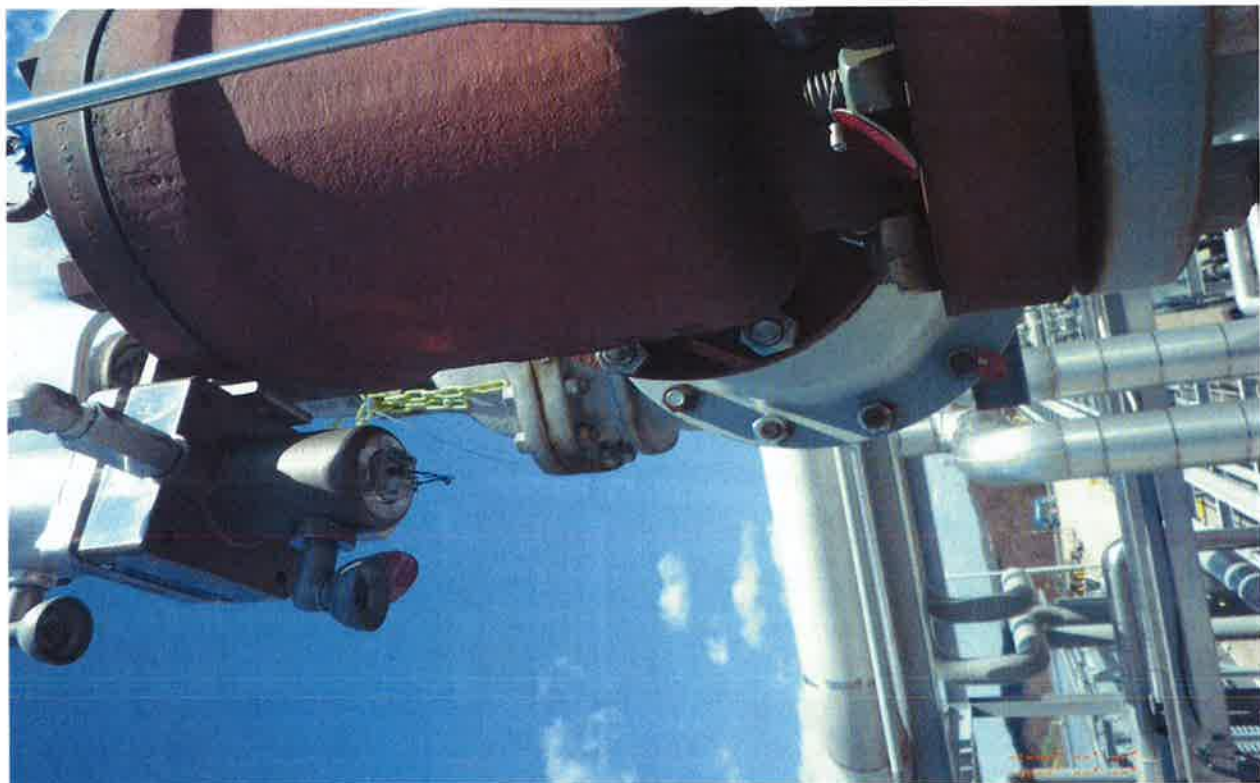
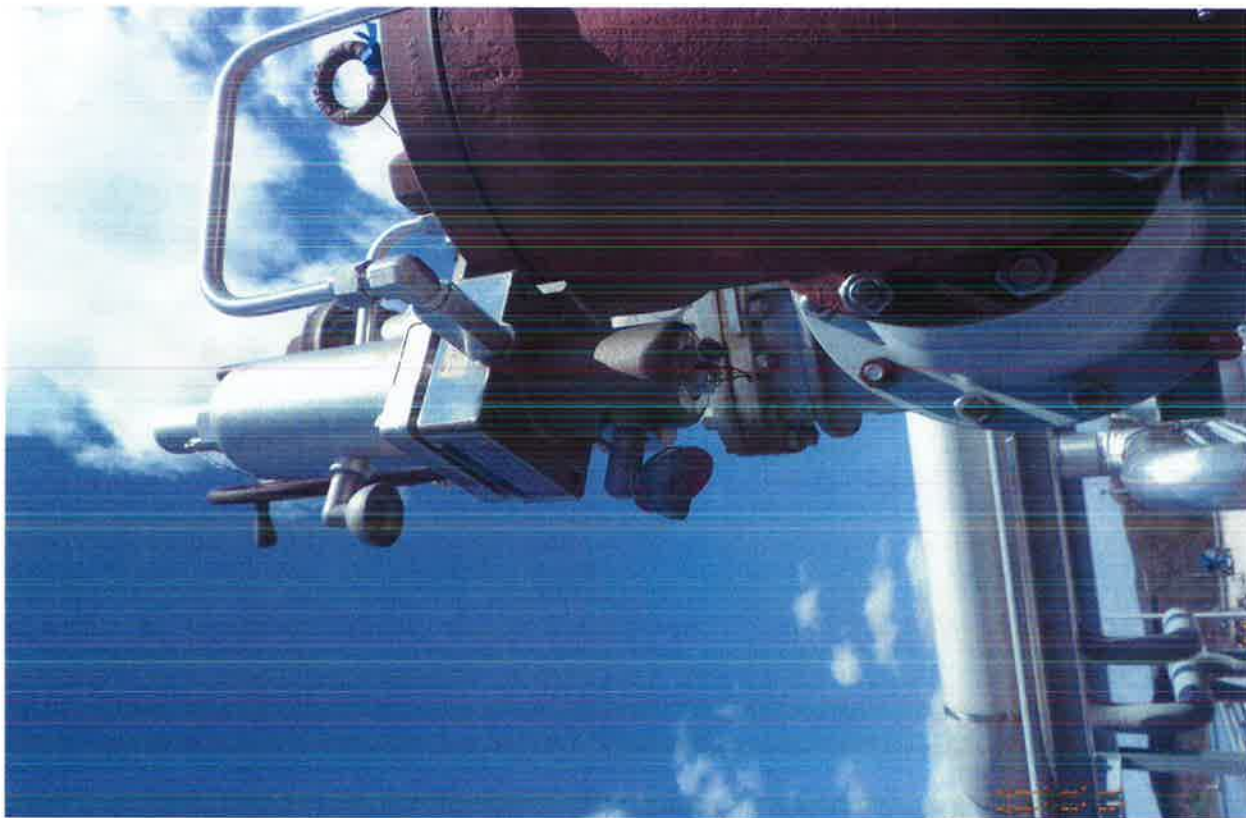
During the third day of the inspection, another brief opening meeting was held to discuss logistics. Mike Conner provided an overview of the Farris pilot operated pressure relief valves that were observed leaking in the plant. Mike indicated that the bottom vent on the assembly is the one that could potentially leak because the O-rings fail which relieves pressure on the internal spring. Mike also provided some manufacturers data on the valves. The TVA devices were calibrated and monitoring commenced in the railroad loading rack area at approximately 0930.

9. MarkWest has failed to capture and control all emissions from process safety valves that are designed with a pilot assist mechanism. Anywhere from 2-15% of pilot can vent process gas without triggering the PSV to vent to the flare header. MarkWest is not accounting for the excess emissions.
10. MarkWest has failed to include all components such as bleeder valves on instrumentation and other valves due to gaps in the MOC process.
11. While inspecting the railcar loading racks, EPA noticed that several of the loading

10. Leaking Pressure Relief Valve – MarkWest Houston – 04/28/2015

11. Second Photo of Leaking Farris PRV – MarkWest Houston – 04/28/2015

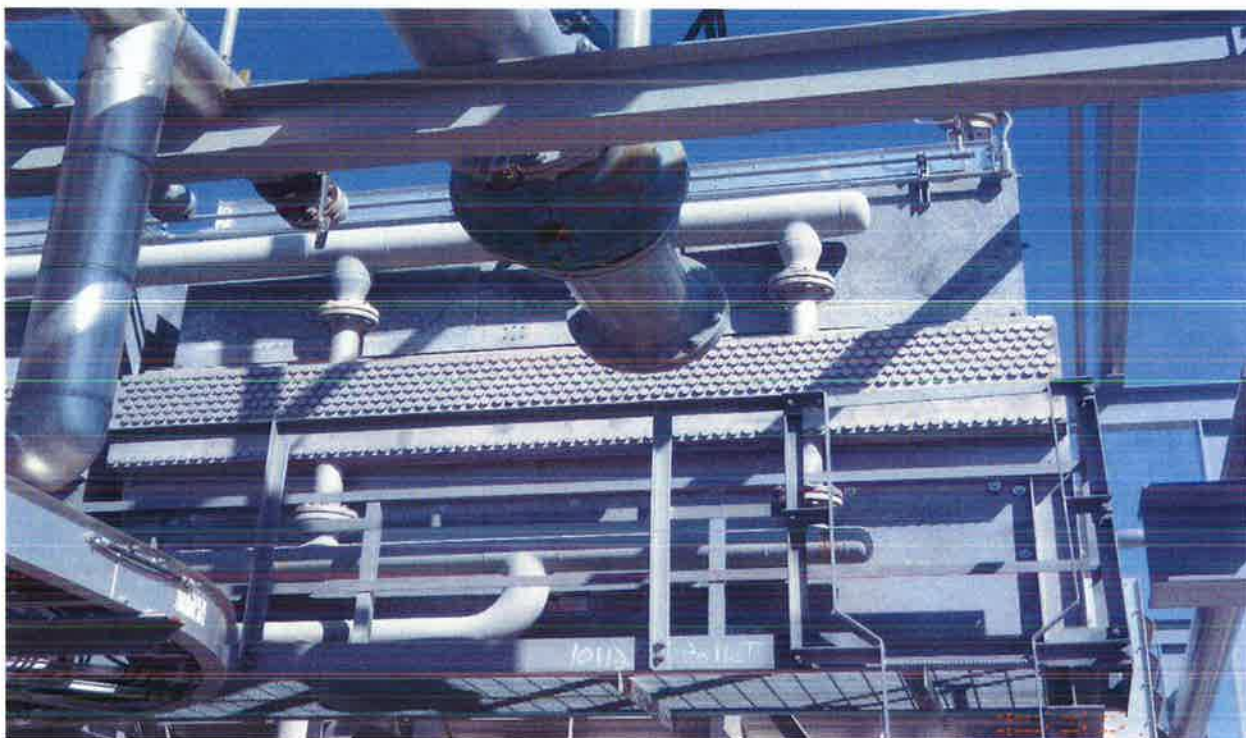
- The connectors on the fin fans in Frac 1 and De-propanizer 5 are not included in the LDAR program. The connectors at the end of the assembly are in contact with process material. The valves and other connectors on the fin fans are included in the LDAR program (See Photo 12 on Page 6 of the Inspection Photos).
- Two valves observed with no tag between V432 and tag 008743
- Two open ended lines observed on 008676 and 008736

7. MarkWest has not included any of the connectors from the fin fans in De-propanizer 3, 4, and 5 and the De-ethanizer in their LDAR program. These components are in contact with process liquids and are potentially subject to Method 21 monitoring.

12. Connectors on Fin Fan De-Propanizer 5 Not Tagged for LDAR – MarkWest Houston – 04/28/2015

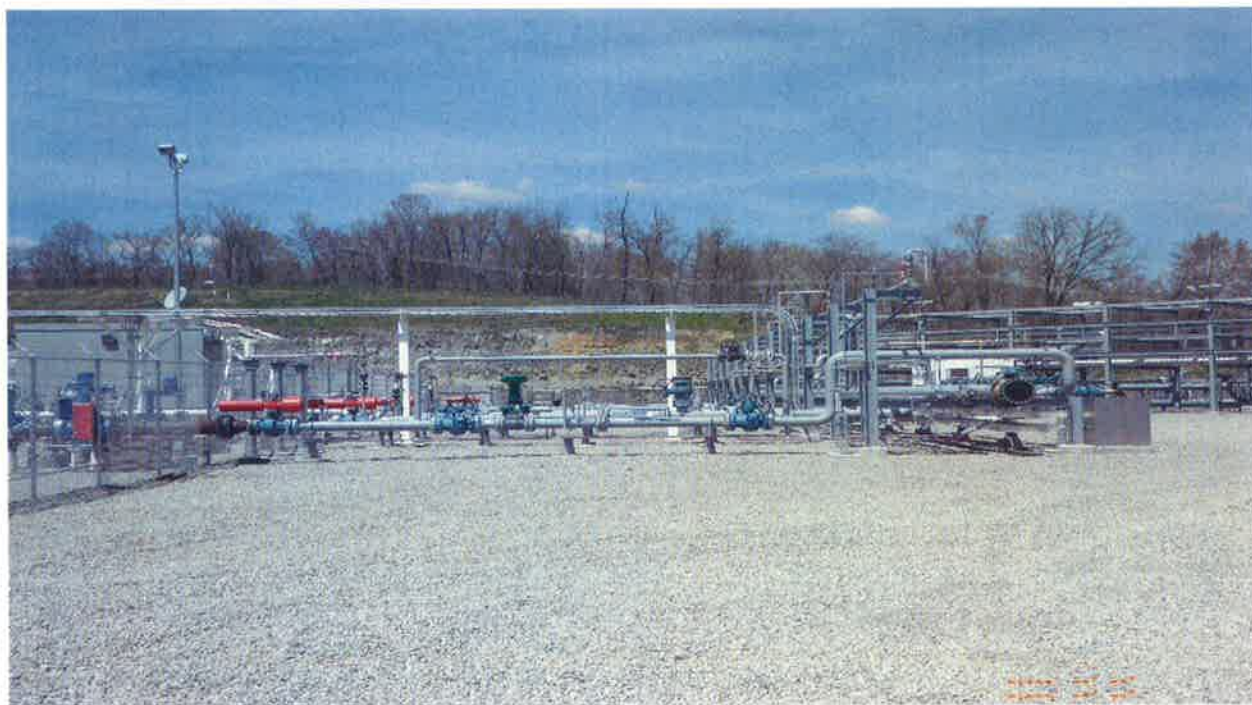
- The Mariner East Pipeline<sup>6</sup> runs adjacent to the facility and there is a tie-in on MarkWest property. There are no LDAR tags on this line.
- There are sporadic tags in the propane refrigeration building with some lines being tagged partially while the remainder of the line isn't tagged.
- EPA observed several hundred LDAR tags on lines downstream of the De-ethanizers which should not be included in the LDAR system.
- At least five valves were observed on insulated lines with no access port for LDAR monitoring.
- There were no LDAR tags on any equipment located in Storage Pad 3. There are nine bullet tanks in this area.

14. Mariner East Propane Pipeline Untagged for LDAR – MarkWest Houston – 04/29/2015

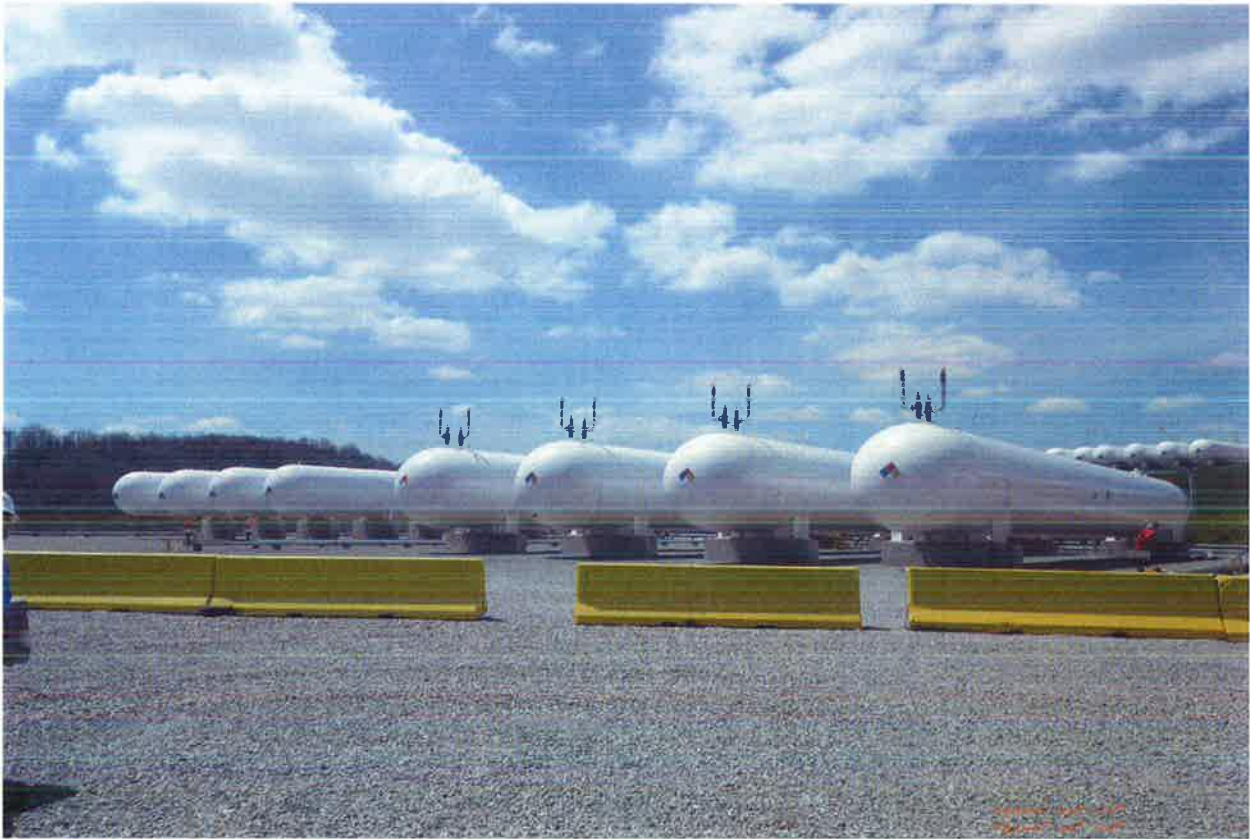
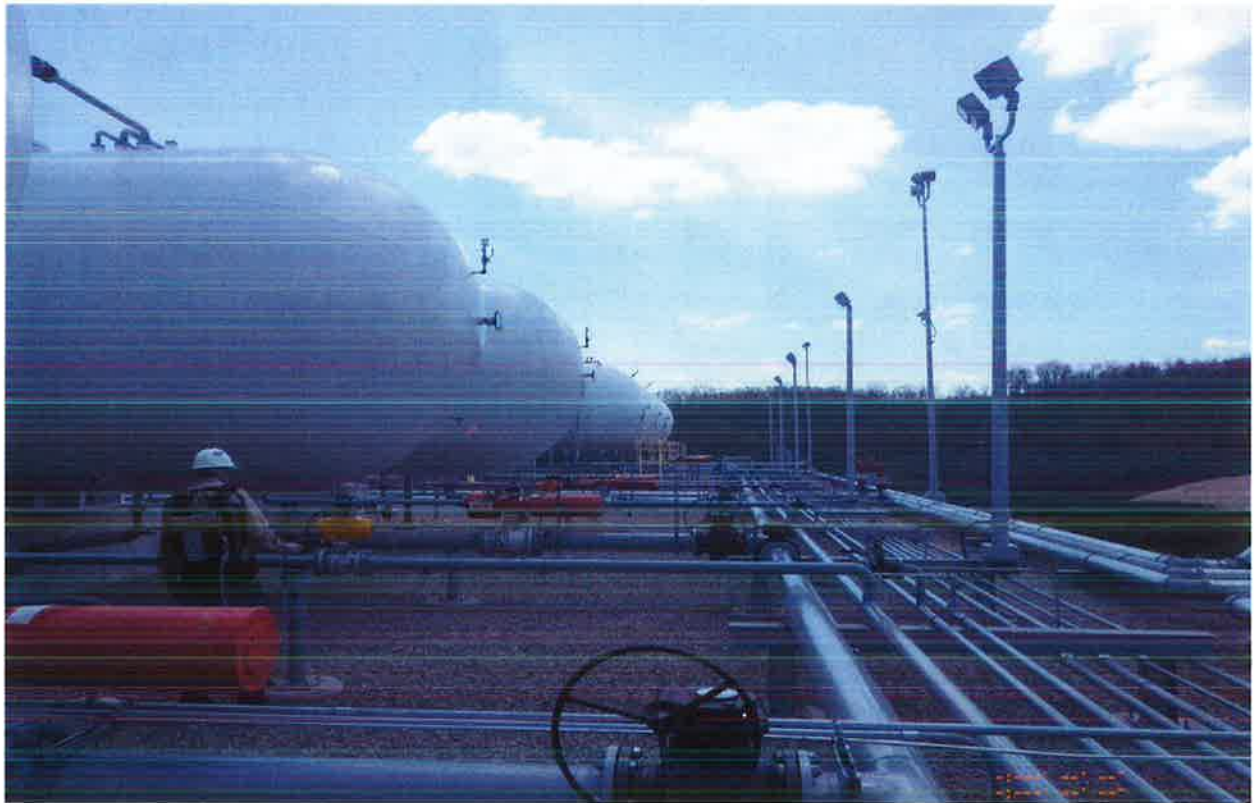
6. There were no LDAR tags and all of the components in the Storage Pad 3 (Nine n-butane storage tanks) were not included in the LDAR program. Mark West commenced identifying and tagging this area while the inspection was ongoing. After the inspection MarkWest stated that 281 valves, 660 connectors, and 18 process safety valves were tagged in this area.

15. Pad 3 N-Butane Storage Bullets – MarkWest Houston – 04/29/2015

16. Second View of N-Butane Storage Tanks – MarkWest Houston – 04/29/2015

18. N-Butane Storage Tank – MarkWest Houston – 04/29/2015

19. N-Butane Storage Area Untagged for LDAR – MarkWest Houston – 04/29/2015

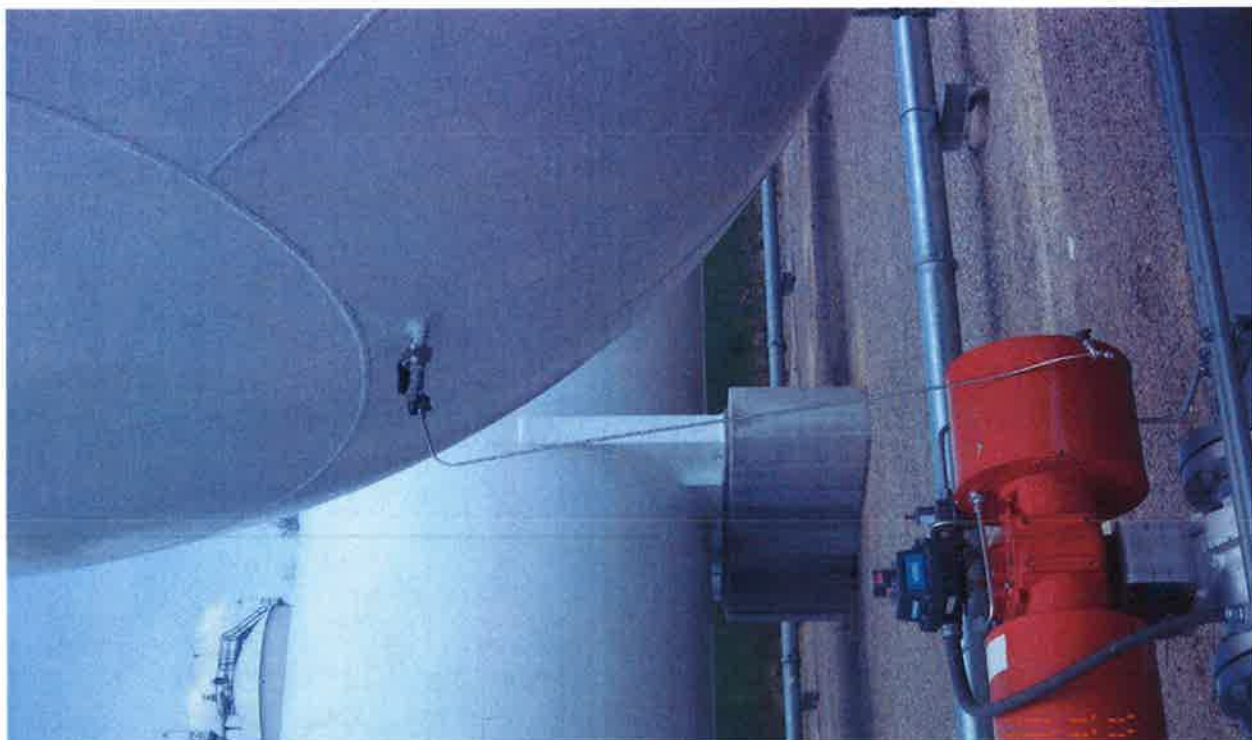
17. Sampling Line from N-Butane Storage Tank – MarkWest Houston – 04/29/2015

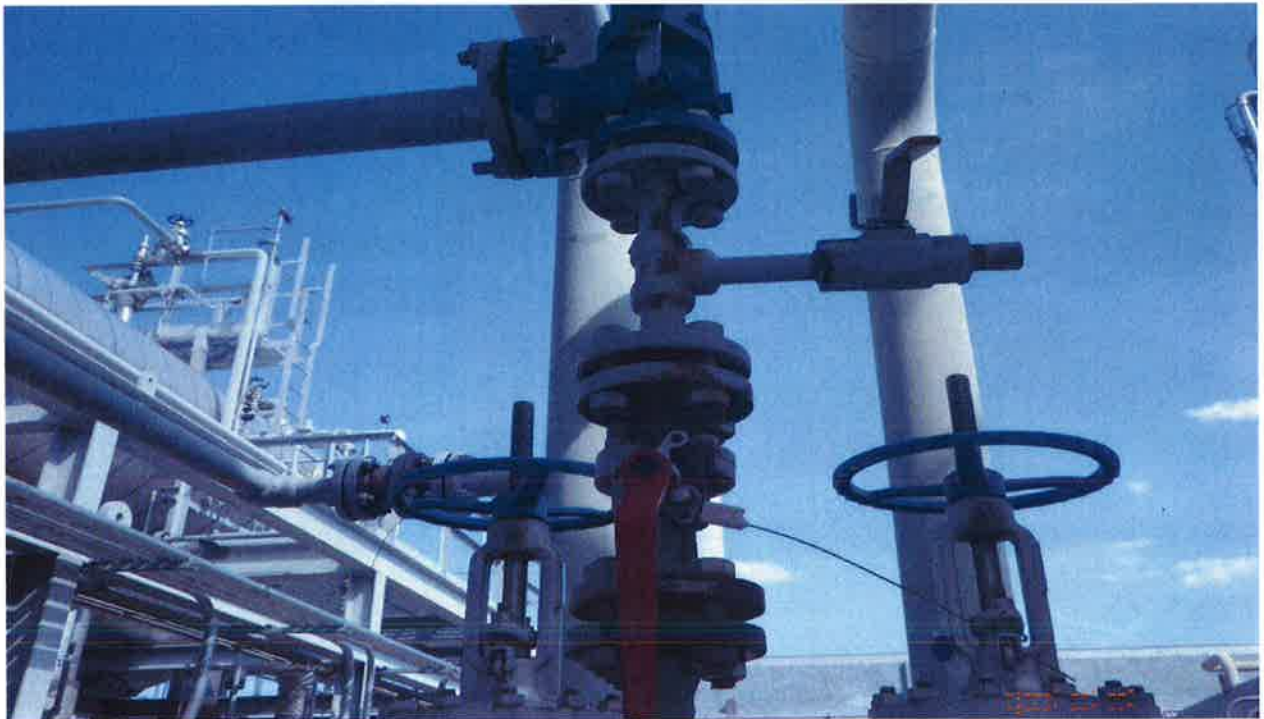
- There appears to be new equipment just after 005524 with no LDAR tags.
- There is a new control valve located between 005775 and 005778 with no LDAR tags. According to the tag on the equipment this valve was calibrated on 09/29/14.
- A new valve between 005779 and 005780 is not tagged for LDAR.

22. Four Missing Tags after 005524 - MarkWest Houston – 04/29/2015

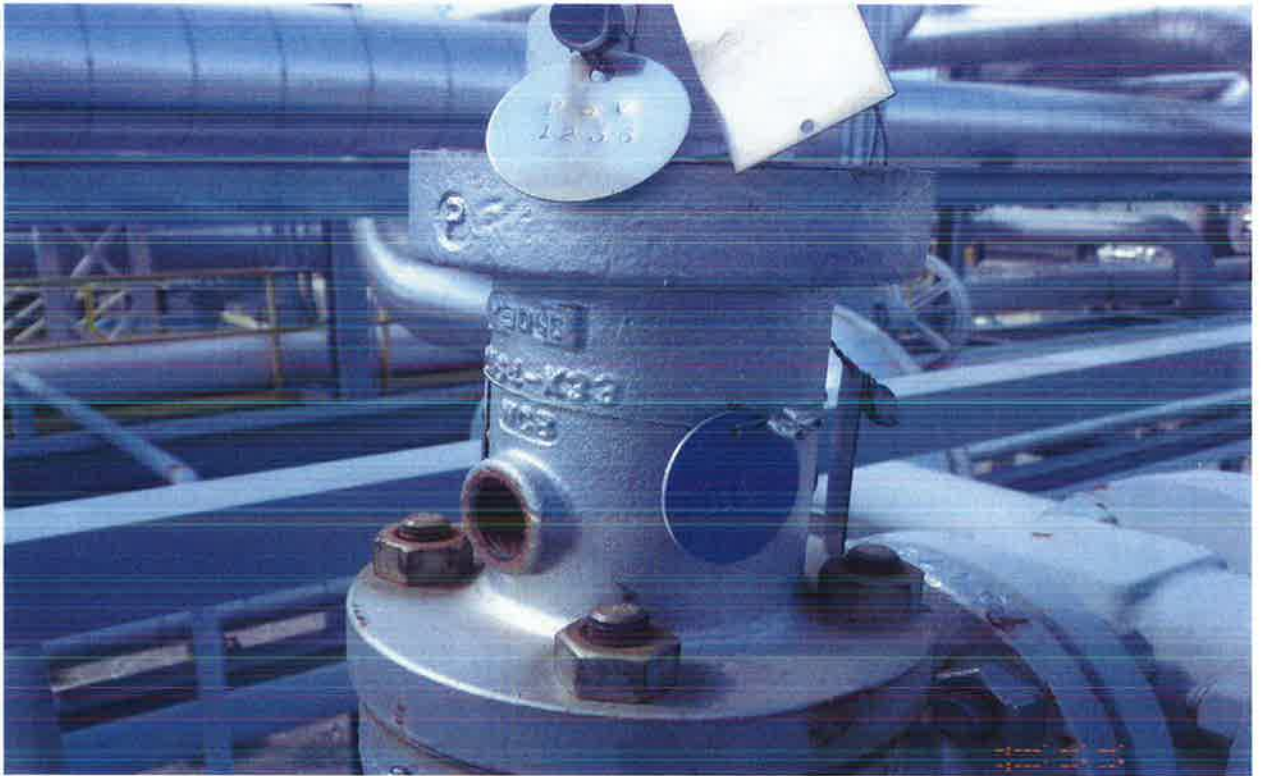
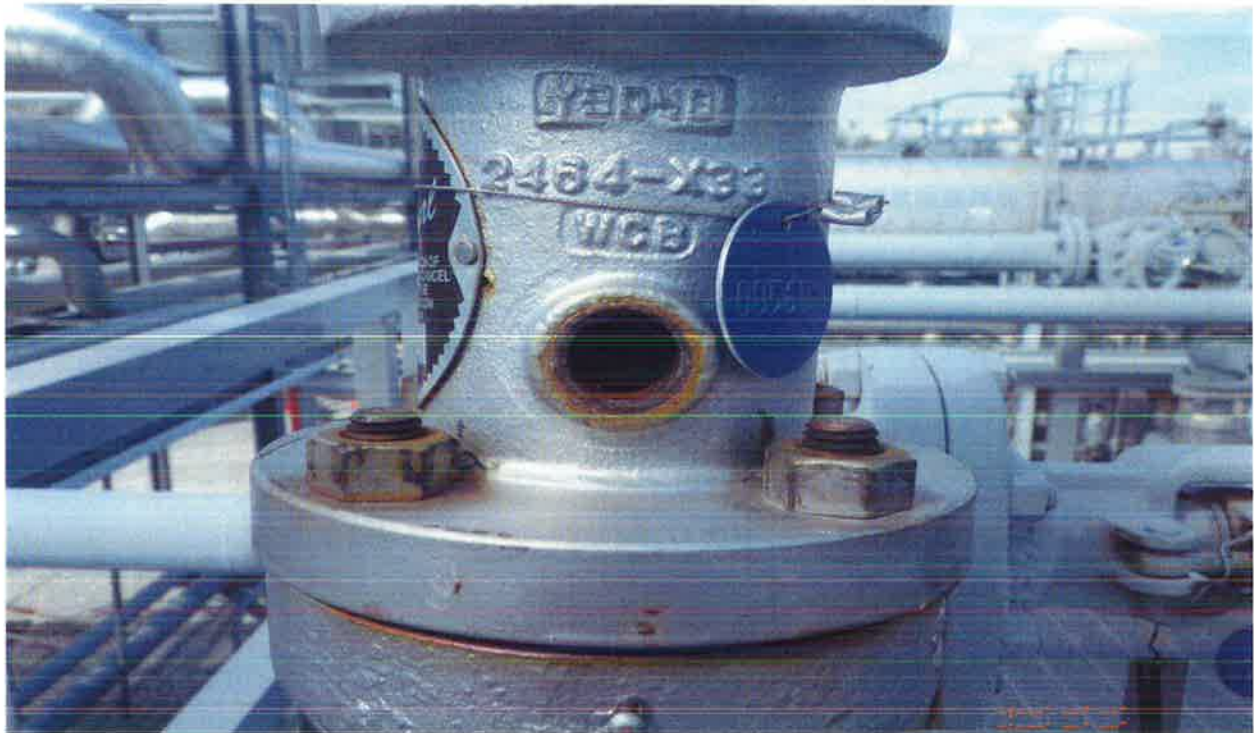
23. Process Safety Valve Open to Atmosphere – MarkWest Houston – 04/29/2015

24. Second View of PSV Open to Atmosphere – MarkWest Houston – 04/29/2015

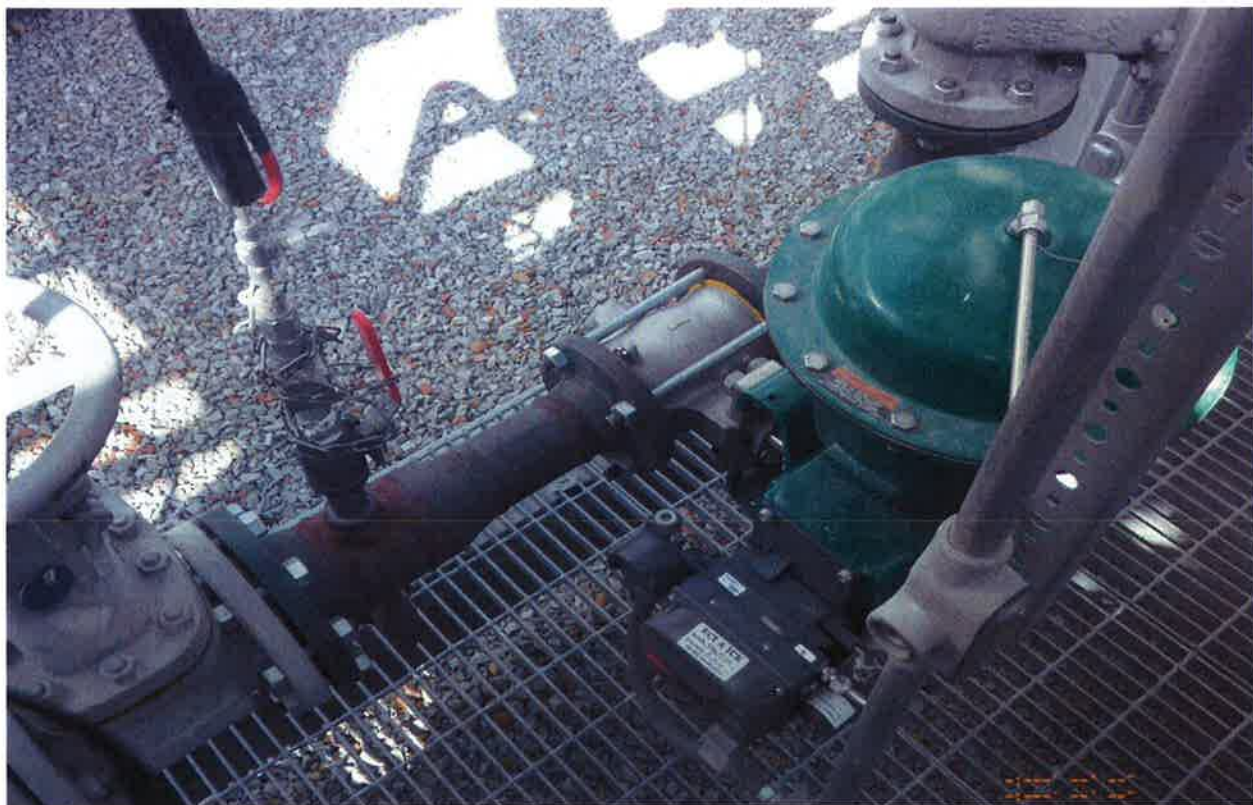
25. New Control Valve between 005775 & 005778 No Tags – MarkWest Houston – 04/29/2015

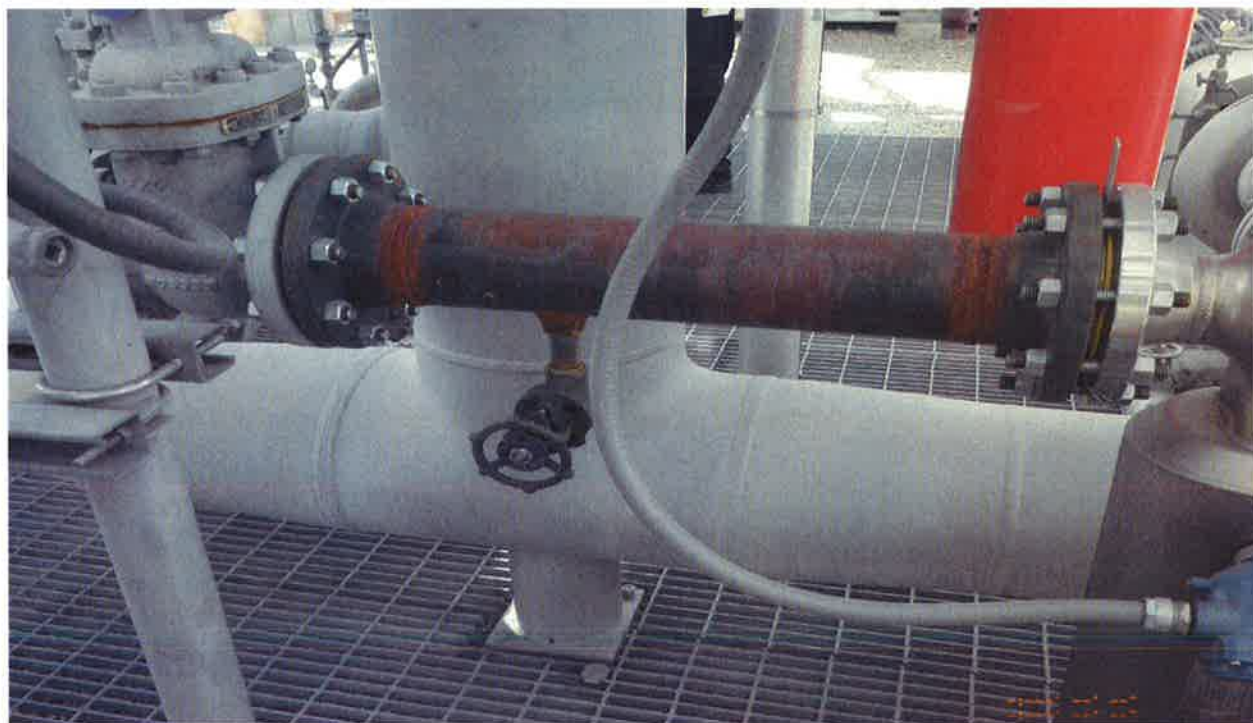
26. New Piping between 005779 & 005780 with NO LDAR Tags – MarkWest Houston – 04/29/2015

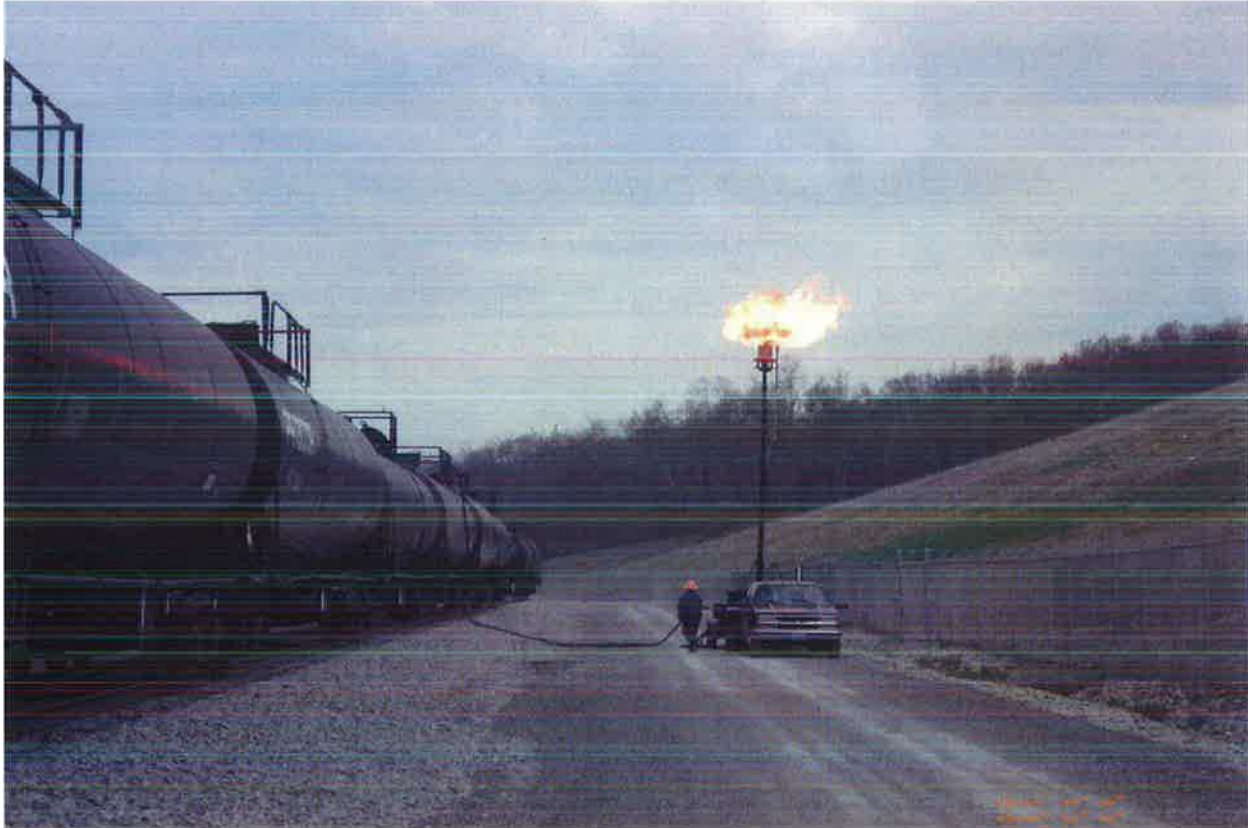
27. Temporary Flare Venting Railcar – MarkWest Houston – 04/30/2015

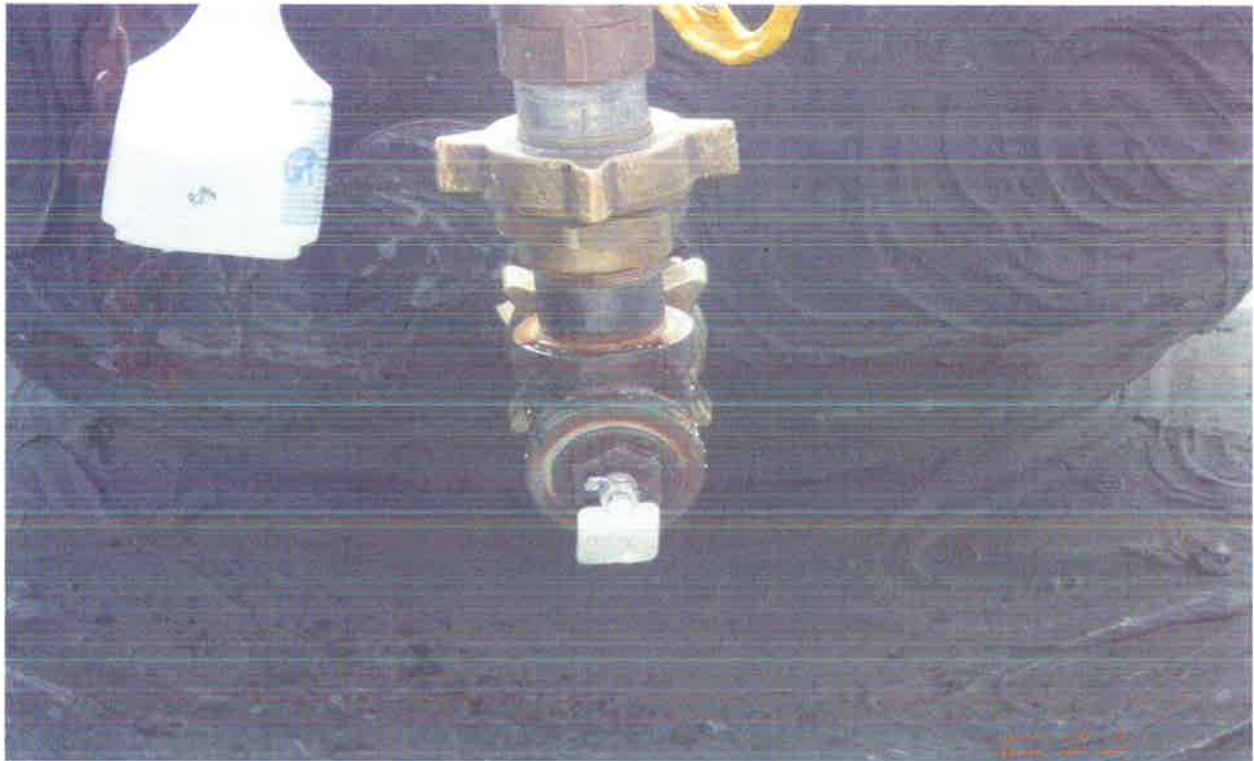
rack arms were missing LDAR tags and that there were numerous leaks where the arms attach directly to the cars. These emissions occur during loading of railcars and are not captured and controlled. Emissions from railcar loading may be under reported to PADEP.

31. Bleeder Valve 010811 on Railcar Loading Station (Leaking) – MarkWest Houston – 04/30/2015
